SUCCESS STORY

ALPHA TIMING BELT

Well Cell Conveyor System

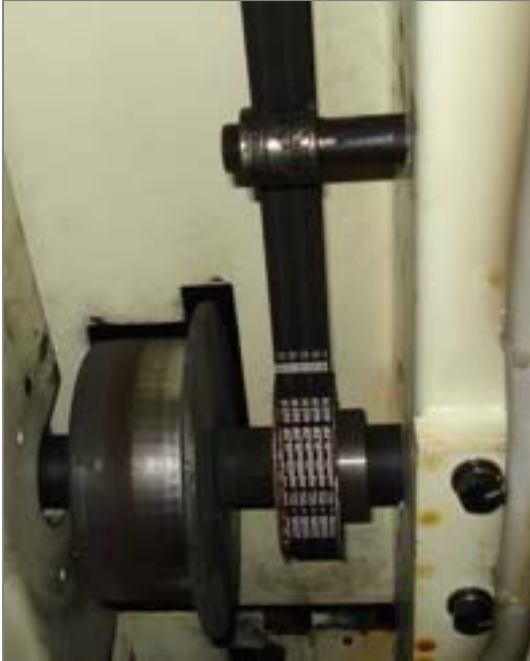
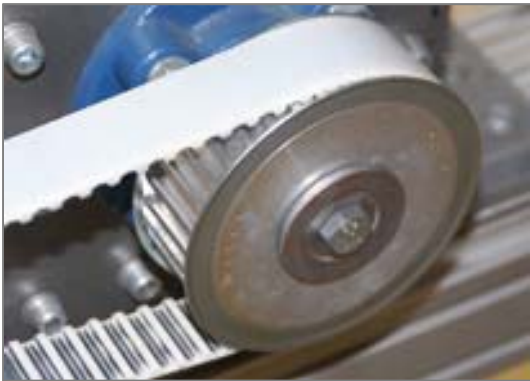
Original design was tensioned by a backside idler pulley with raised ridges. The idler pulley was wearing the backside of the rubber timing belts. Belts failed frequently and required constant maintenance and downtime.

The rubber timing belt was replaced with an Alpha polyurethane timing belt. Due to polyurethane's much higher abrasion resistance, the amount of wear from the idler on the belts was significantly reduced. The decreased wear rate on the belts allowed for significantly decreased downtime.
